ARCHAEOLOGICAL FINDS FROM THE VAULTED BUILDING AT KRŠEVICA

Abstract: The completely preserved building with barrel vault was discovered in 2008 in the course of investigation of the remains of an urban settlement dating from the 4th /3rd centuries BC at the site Kale in the village Krševica (southeast Serbia). We are presenting in this work the archaeological finds discovered in this structure. They included pottery, worked stone and many skeletons of horses and dogs that are assumed to be the ritual sacrifice.

Key words: Kale-Krševica, urban settlement, vaulted building, cult, 4th /3rd centuries BC.

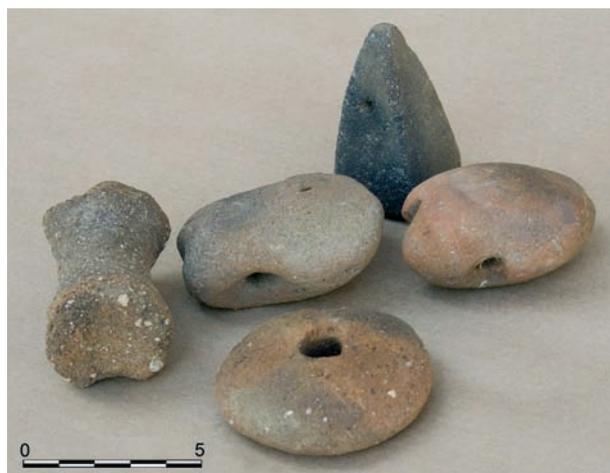
Fig. 7. Pottery finds: loom weights, spool and spindle whorl

without clear details, and as there are no analogies it is difficult to reconstruct the motif. For the time being both specimens must remain the unsolved problems. The spool, spindle whorl and few loom weights are considered as common finds at this site (fig. 7).⁸ After the last year excavations total number of discovered loom weights certainly exceeds 1,500 specimens.

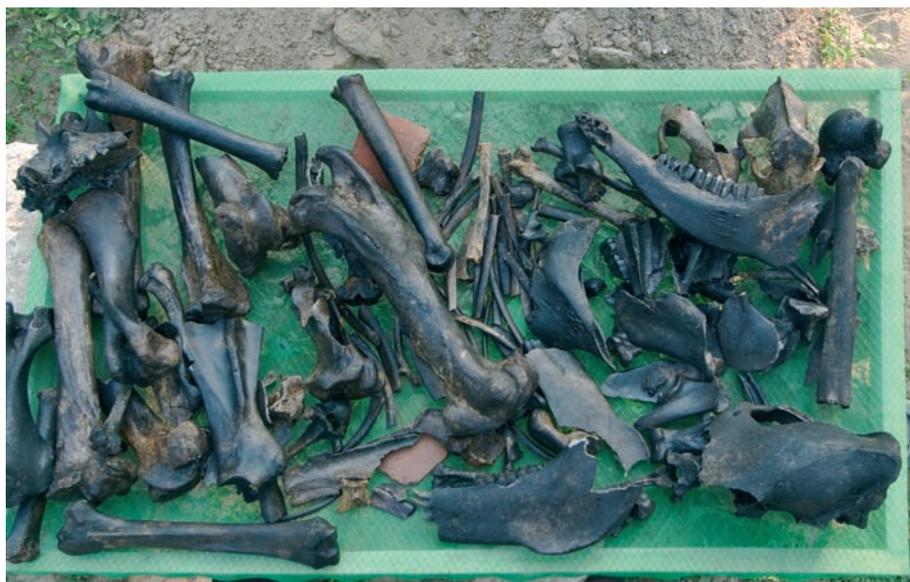
Fig. 8. Animal bones

common (fig. 8).⁹ The preliminary analyses revealed that bones of sheep/goat, pig, game, including deer, wild boar, badger, hare, duck and few turtles represent very small percentage (except four turtles, there is just a single representative of every species) of the entire assemblage. If we add also the discovered bovine skeleton this amounted to 15% of the total quantity of

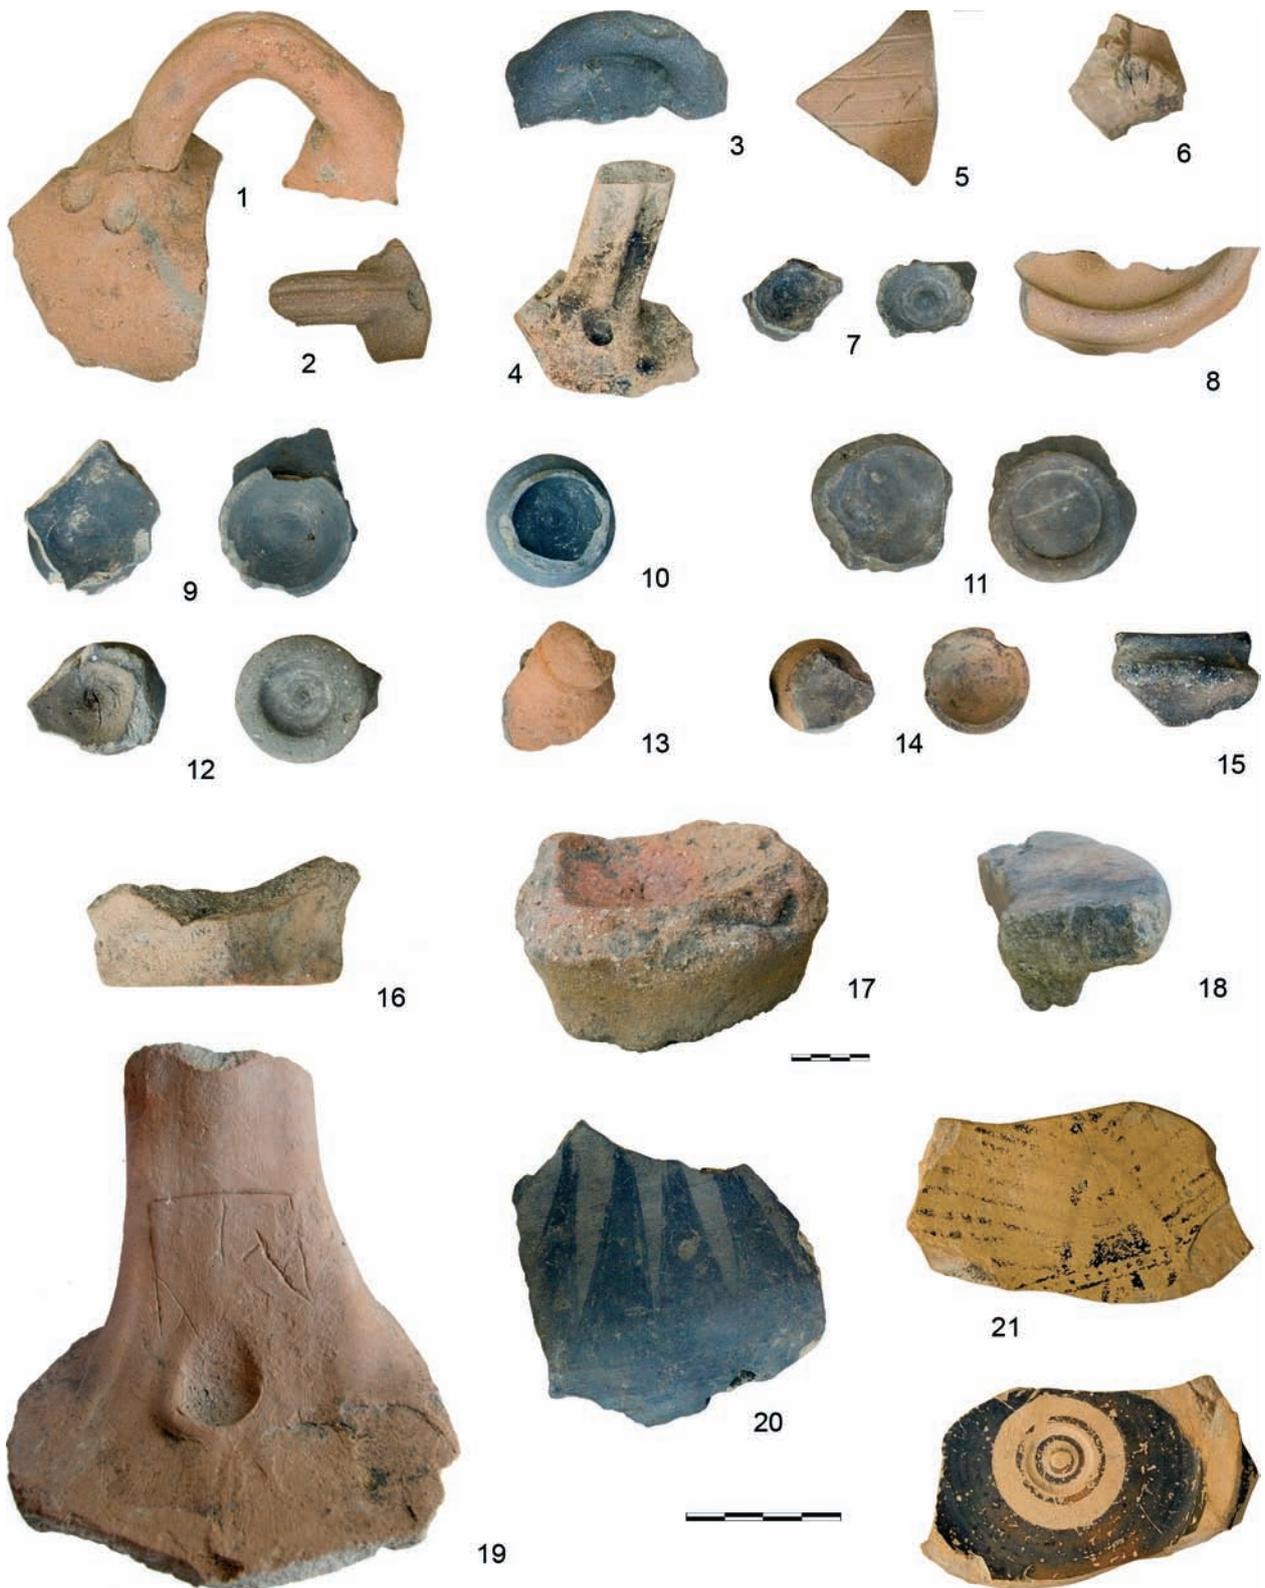
Plate I - Pottery fragments
Tabla I - Фрагменти керамике

denote number 5 relating to its value or capacity.⁶ However, letter *II* is here surrounded with one vertical *I* and few slanting incisions, which are difficult to explain (Plate I. 19). Worth mentioning here is one base with engraved mark X that is not a rare phenomenon on various vessels from Krševica (Plate I. 11).⁷ Rather scarce handmade pottery is represented by the fragments of coarse pots with horseshoe-shaped handles (Plate I. 15). Finally, we would like to mention another two, apparently, most interesting specimens. One is the fragment of shoulder and body of the wheel-made vessel of dark gray color and with burnished surface. The triangles like sun rays with incisions and dots are depicted on the shoulder (Plate I. 20). The other specimen is a fragment of plate made of yellowish clay with brown painted concentric circles at the bottom. On the inside are depicted two inscribed triangles surrounded by the rays and the horizontal band with dots (Plate I. 21). Section of the central motif is rather worn out,

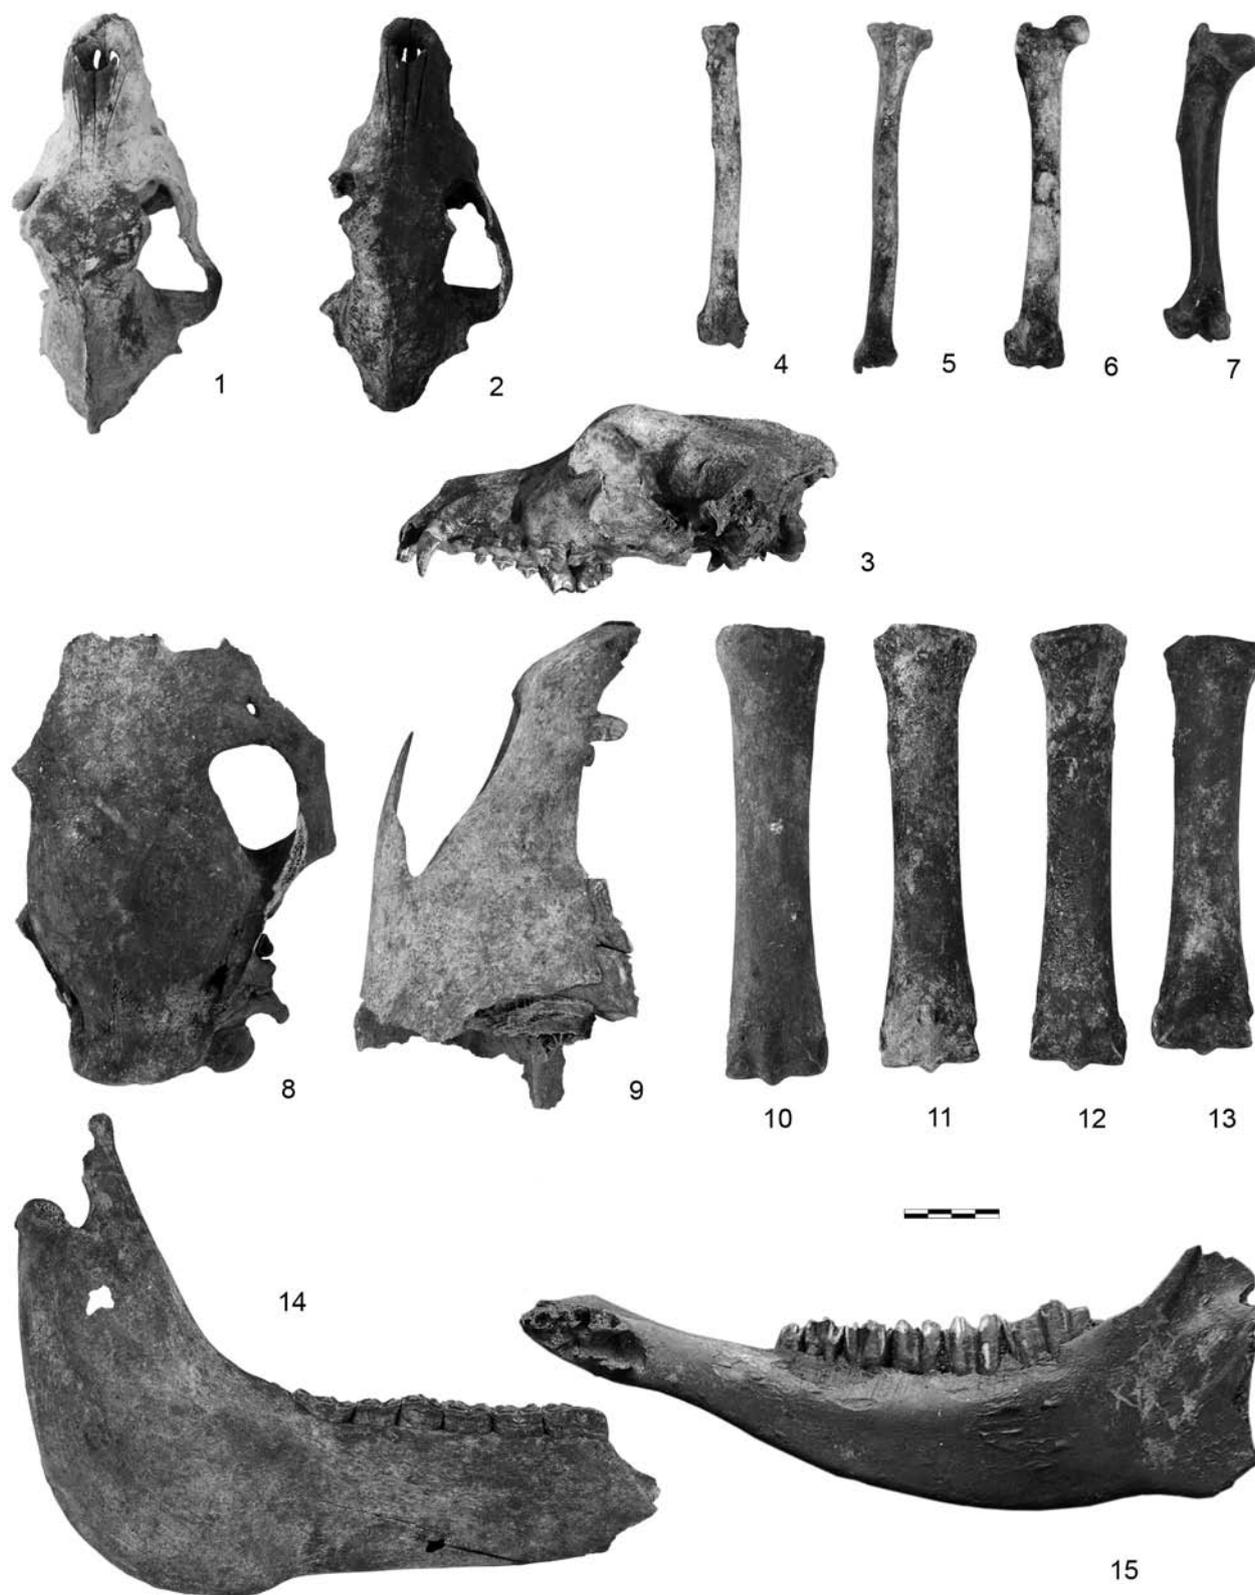
Plate II - Animal bones: 1-7 *Canis familiaris*, 8-14 *Equus caballus*, 15 *Bos taurus*

The horses were also adult individuals but in contrast to the dogs all were rather young animals. The bones are mostly fragmented but according to the teeth wear and complete development of long bones it could be concluded that they were between four and six years old. The withers height estimated on the basis of the length of complete bones is between 133 and 151 cm, the average height being 143 cm. According to the teeth in the lower jaw and the pelvic bones three individuals were males and for the rest the gender could not have been determined with certainty.¹⁰
